CALIFORNIA DIVISION OF MINES AND GEOLOGY

FAULT EVALUATION REPORT FER-85

January 23, 1979

San Jacinto, Hemet area (includes segments of the Casa Loma, Claremont, and Hot Springs faults).

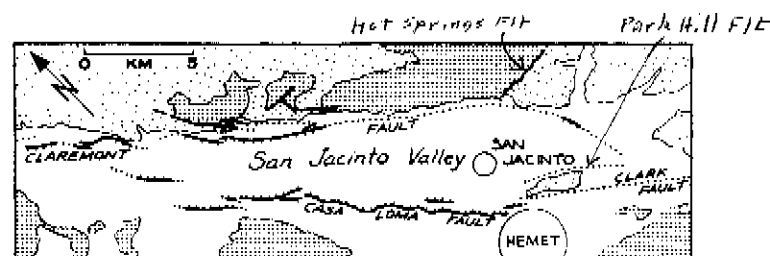
In order to properly identify the active faults for the purpose of rezoning, it is necessary to understand the structural setting of the Hemet area in terms of recent tectonics. According to Sharp (1975), the San Jacinto Valley is a graben (trough) formed by large-scale strike-slip ^{displacement is} faulting (estimated 15 miles) and extensional opening between the Claremont and Casa Loma-Clark faults. This relationship is shown in Figures 2a and 2b.

Figure 2a. Fault pattern in San Jacinto Valley. Heavy lines are faults, hachures on downthrown sides. Dark stipple: Mesozoic and older crystalline rocks. Light stipple: Pliocene and Pleistocene continental sedimentary rocks. Unstippled areas: Quaternary alluvium. (After Sharp, 1975.)

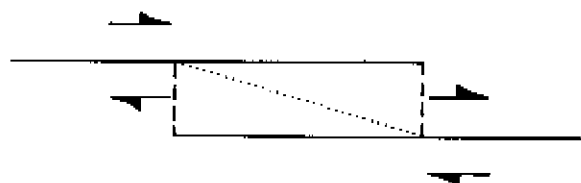
Figure 2b. Diagram of overlapping echelon faults. Solid lines are fault traces, dashed lines bound area of overlap, dotted line shows possible orientation of single fault at depth. Arrows show direction of relative movement. (After Sharp, 1975.)
